# TIRE CASING RETREAD AND REPAIR MANUAL FOR ECDII™ AND DURASEAL TECHNOLOGY™

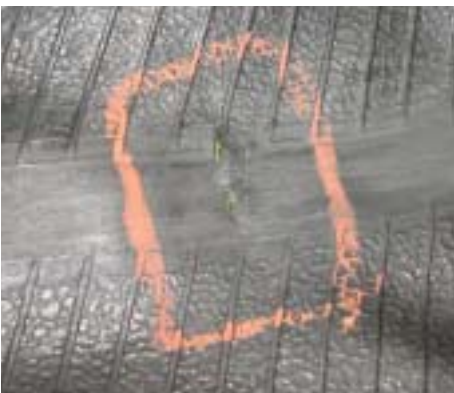
Figure 1

The appearance of the liner in casings with DuraSeal Technology may be different than standard casings. The liner may be loose and look separated in the crown area (*Figure 1*). Normally, the liner is tight to the casing from the bead to the upper sidewall/shoulder.

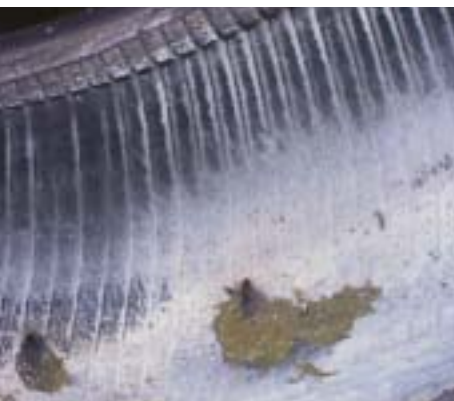
Figure 2

The DuraSeal Technology compound, while not liquid, is fluid enough to move or migrate in service. When filling a puncture, the compound may migrate out of the liner and, in some cases, may even be visible on the outside of the tire. There may be areas of the liner where the compound has moved and will create a depression. Other areas may have an accumulation of sealant material and exhibit lumps or thick spots (*Figure 2*). This is considered normal. The consistency of the compound will even out when the tire is in service.

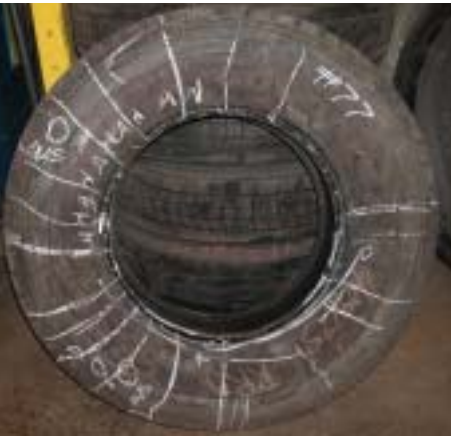
Figure 3

In the most severe waste haul applications, casings may accumulate high numbers of metal pieces (nails, screws, miscellaneous debris, etc.) in the tread area (Figure 3). This is due to the success of the DuraSeal Technology at sealing punctures. Because of this, tires do not need to be removed from service as often, or as early in the tire's service life, allowing the tire to continue to accumulate debris. When the tire is being repaired, this may lead to longer than normal time required to detect and remove metal debris and investigate the need for permanent repairs (Figure 4).

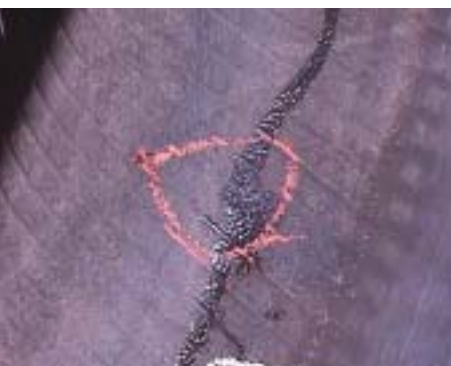
Figure 5

Casings with DuraSeal Technology that have been stored outdoors need to be inspected for signs of water in the casing. Since the liner does not adhere tightly to the casing in the tread crown area, it is possible for water to become entrapped between the liner and the body of the casing. Clear liquid running out of a puncture in the liner (Figure 5) will indicate water in the liner. The existence of water in the casing will prevent the casing from being retreaded.

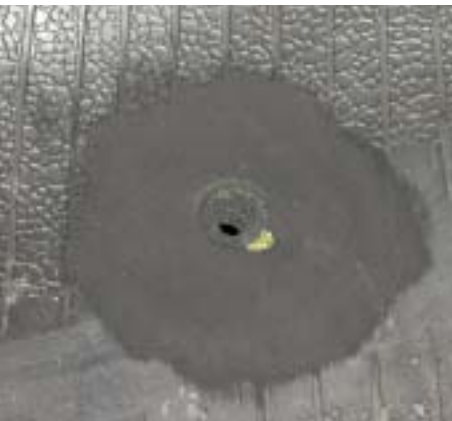
*Figure 6*

6. Carefully buff the liner without excessive pressure. However, all bladder vent patterns must be removed (*Figure 6*). An alternate option to using a tungsten carbide rasp to buff the liner is to use a soft wire brush to achieve a RMA #1 texture and lessen the chance of tearing the liner.

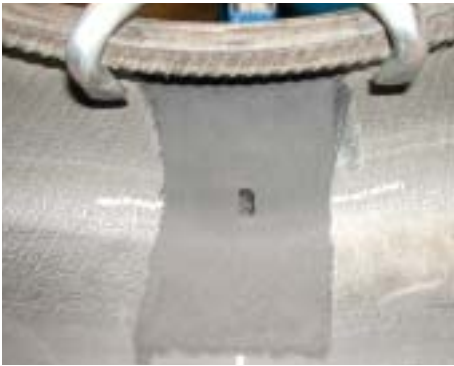
Figure 7

Section repairs where the injury is in the sidewall should not result in any additional difficulty (*Figures 7 and 8*). Care must be taken when buffing the liner in the sealant area since it may not be firmly attached to the casing. DuraSeal Technology compound does not extend beyond the belt edge/shoulder area, so it will not affect preparation on the sidewall section to be repaired.

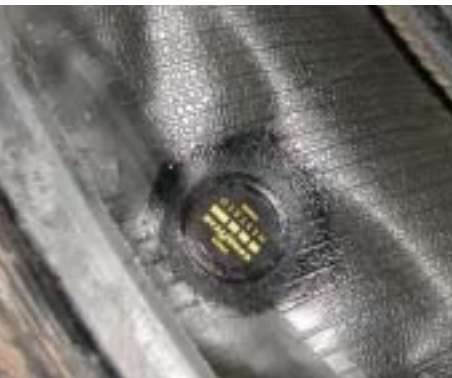
*Figure 9*

When the retreaded casings are removed from the curing chamber, the liner may appear separated. Normally, the liner should be tight to the casing from the beads to the upper sidewall/shoulder. However, in the tread crown area where DuraSeal Technology is present, the liner may swell or bubble and appear separated (*Figure 9*). This is normal for casings with DuraSeal Technology. The air will dissipate when the tire cools.
